ENGINEER'S DESIGN / CHECK / INTENT TO INSPECT CERTIFICATE

PROJECT DESCRIPTION: ROOF BRACKETS

Pullout test on Thermal spacer report

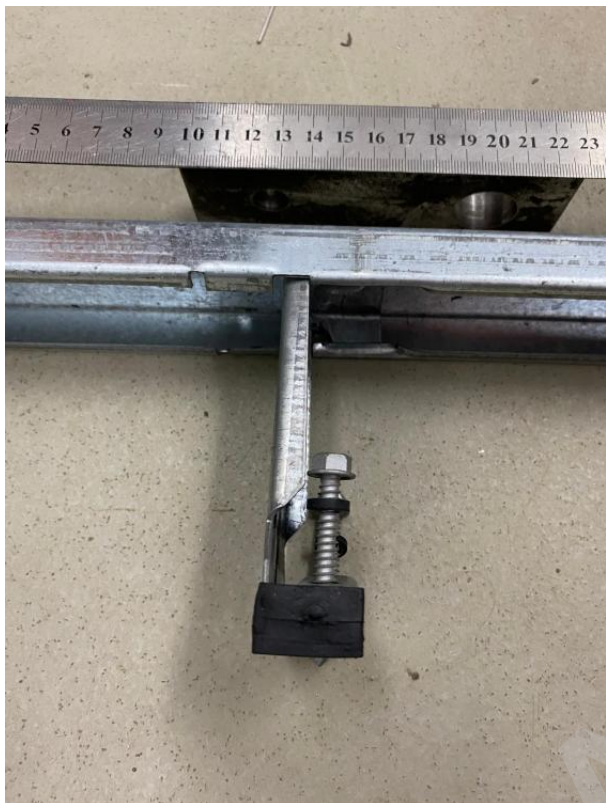
Image 1 of 4 - Section of the supplied Thermal spacer bracket

A section of the supplied thermal spacer (refer Photo 1) was mounted on a specially designed fixture to enable secure gripping by the hydraulic jaws of the tensile testing machine (refer Photo 2). The test specimen was aligned to ensure axial loading, and tensile force was gradually applied at a controlled rate until failure occurred. The force and displacement were continuously recorded throughout the test.

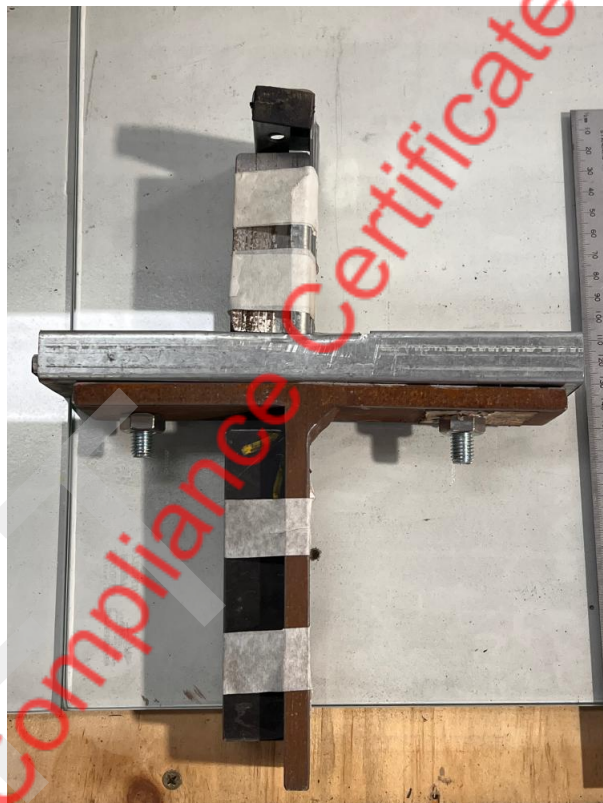
Image 2 of 4 - Test sample with fixture

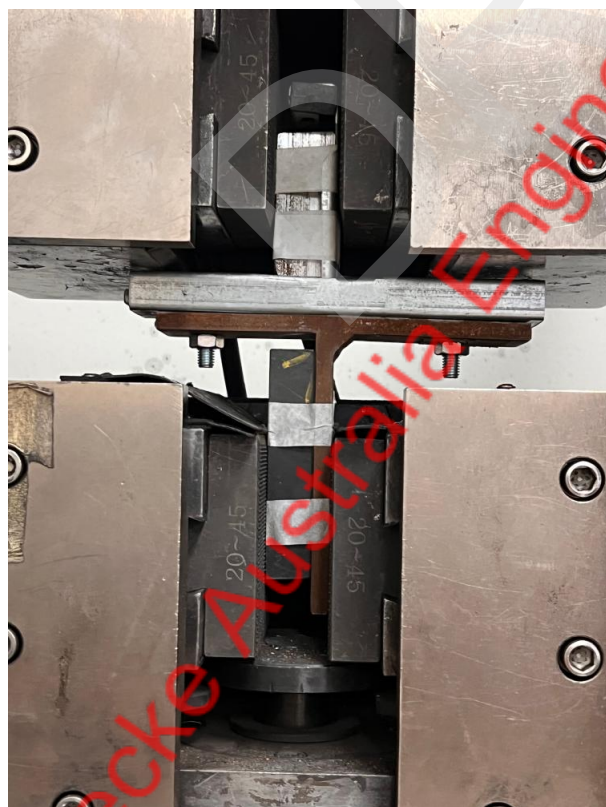
Image 3 of 4 - Test setup on tensile machine

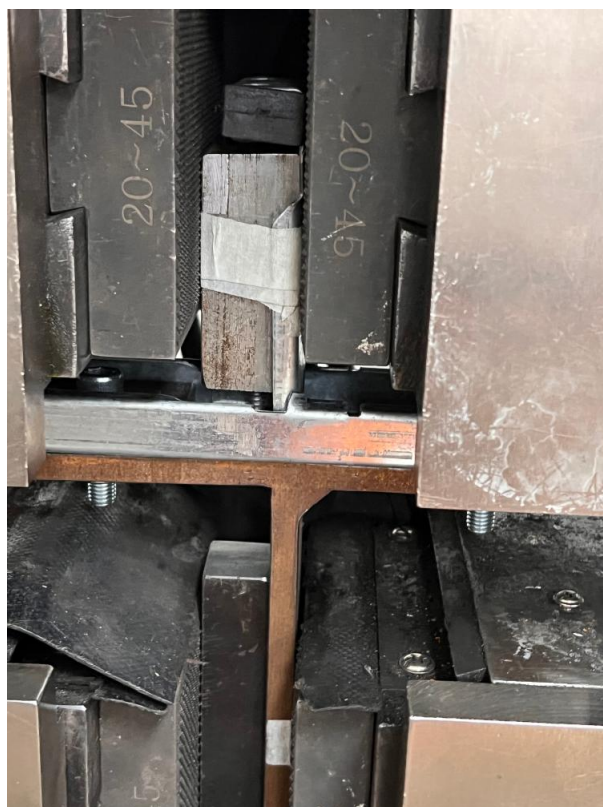
Image 4 of 4 - Failure location at ultimate load

The ultimate load recorded during the pull-out test was 6.8 kN, representing the maximum force required to dislodge the leg of the thermal spacer from the rail. The failure location is shown in Photo 3, which indicates that failure occurred at the interface between the leg and the rail engagement area.

The pull-out test demonstrated that the thermal spacer exhibited an ultimate pull-out strength of 6.8 kN under the specified test conditions. The failure mode suggests that the primary mechanism of failure was material separation at the leg-rail interface. These results can be used to assess the adequacy of the spacer's mechanical performance under service conditions.

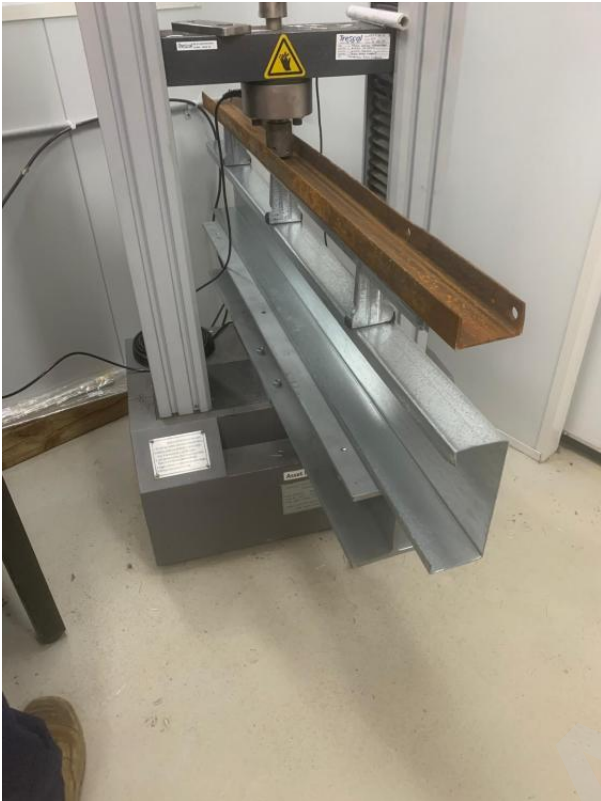
Image 1 of 3 - General view of the test setup

The thermal spacer was fixed to the purlin, and a uniformly distributed compressive load was applied to measure the maximum load the spacer could sustain before failure (Photo 1).

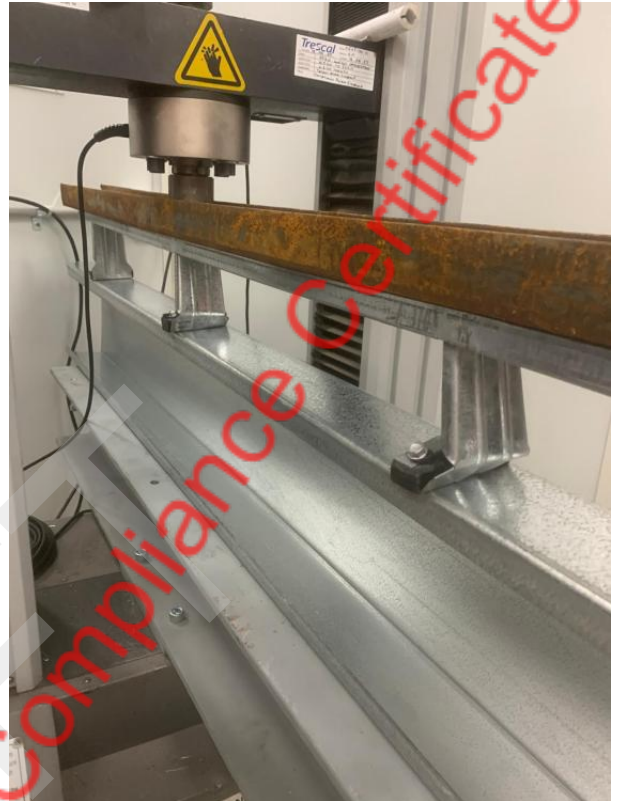
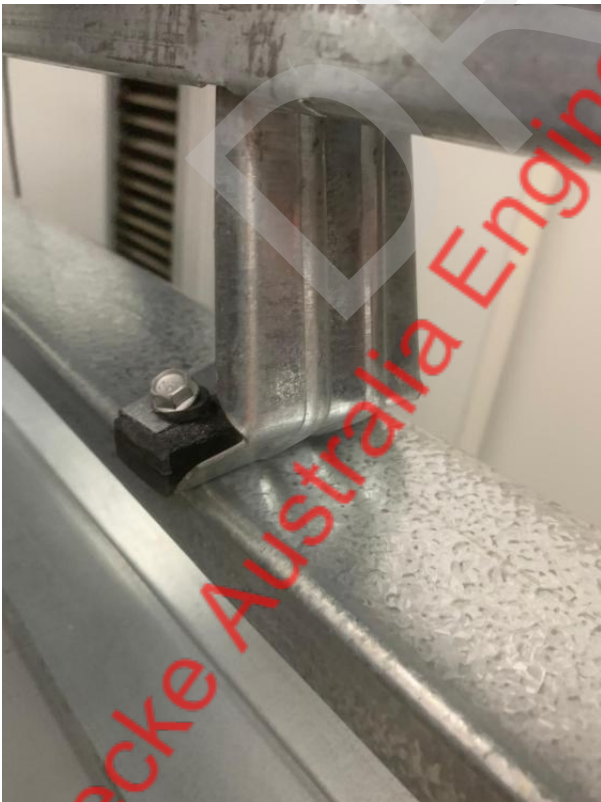
Image 2 of 3 - After Test - failure location

Image 3 of 3 - After Test - failure location

The ultimate compressive load recorded during the test was 9.4 kN, representing the maximum force the thermal spacer could withstand before failure. The location of the failure is shown in (Photo 2, 3).

The compressive test demonstrated that the thermal spacer exhibited an ultimate compressive strength of 9.4 kN under the specified test conditions. The observed failure mode indicates that failure occurred primarily through material crushing at the point of maximum stress. These results can be used to evaluate the adequacy of the spacer's mechanical performance under expected service loads.
